### Flash Fire Inside Diesel Tank

#### SUMMARY

While removing a deck plate inside a tanker diesel tank, a small amount of material leaked from a drain line resulting in a flash fire.

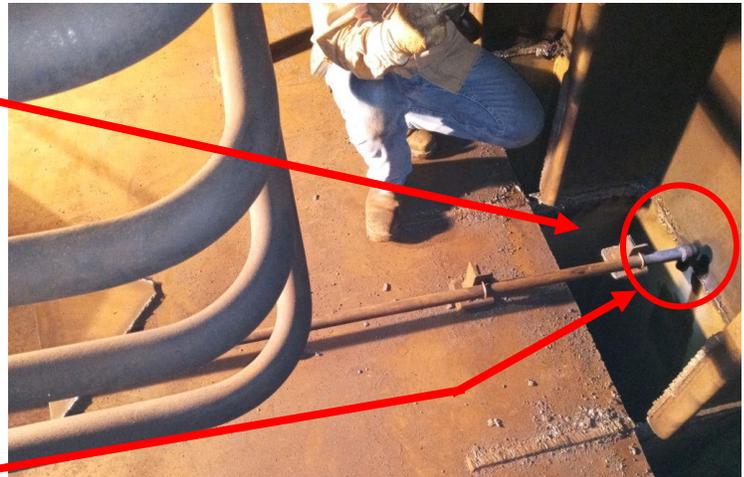
Pneumatic Plug

The intake of a ½" drain line used to drain water from the bottom of the diesel tank was directly over the section of plate that was being removed.

As the worker manipulated the pipe to cut the deck plate directly underneath, a small amount (exact quantity unknown) of liquid leaked out of the intake to the void space below. The worker and ship's crew on-site assumed it was condensation and hot work was continued.

As the worker continued torch cutting, sparks and slag fell into the void and ignited the material. A Fire Watch was on duty and immediately extinguished the fire. No injury or damage occurred.

Suspected that either the isolation valve had a slow leak or residual material trapped in a low spot of the pipeline was discharged when the worker moved the line to gain access to the plate below. Personnel involved made a false assumption rather than contacting the supervisor or Shipboard Competent Person (SCP) for verification. In addition to isolating valves, consider blocking open end of pipes (intake or outflow) with plugs, caps, or other similar methods where applicable in hot work areas. Be sure to discuss the entire processes, such as "run back" during the JHA or safety talk. Any time there is "run back", the space should be exited and retested by the SCP due to a potential change in atmospheric conditions.
