INCIDENT: UNSAFE RIGGING PRACTICE NEAR MISS

SUMMARY OF RECENT INCIDENT

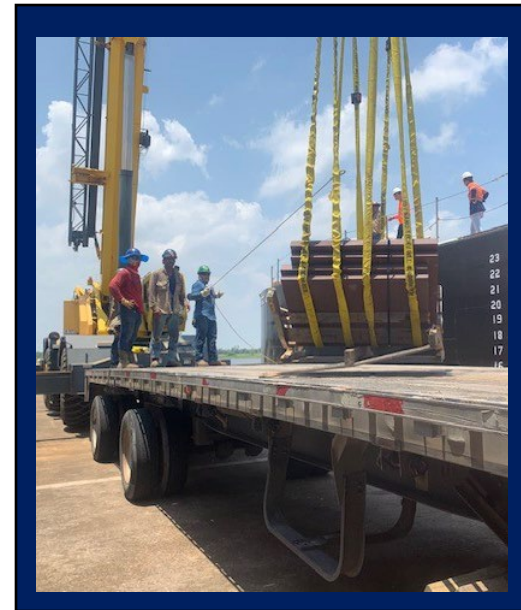
After delivery, personnel working on the vessel at the port were not anticipating that the load would be palletized and had already positioned the crane for loading. Rather than adjusting the plan, the riggers attempted to move the load and rigged the entire pallet with a basket hitch.

Fortunately, the operator followed his instincts and training to slowly lift the load and hold it at about one foot to test the load's stability. In the middle of the test lift, the pallet broke and was promptly set back on the truck bed with no resulting injury to personnel or damage to equipment.

All rigging gear must be rated to manage the anticipated load, and the capacity must be labeled. Always use equipment that is rated correctly for lifting operations. Plan ahead and communicate necessary details with the Rigging Department, such as anticipated lifting points, equipment to be used, center of gravity, travel path, landing destination, and other lifting instructions to facilitate the efficient and safe transfer of materials.

When unexpected circumstances occur, STOP and rethink the plan. In this case, an extended boom forklift was available and could have easily been substituted to safely move the load onto the vessel.
