INCIDENT: FIRE HOSE COUPLING SEPARATION

RECENT INCIDENT

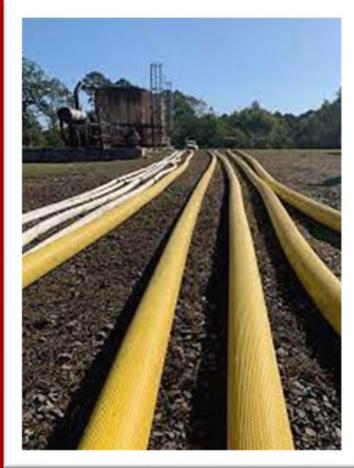
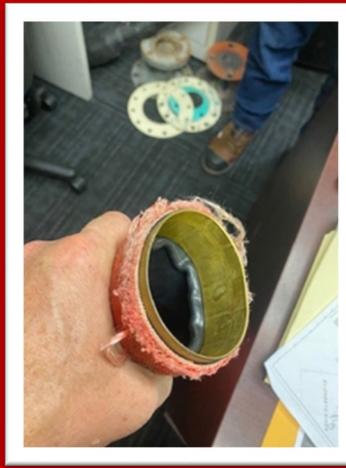
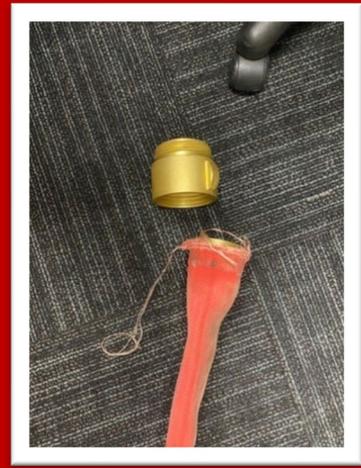
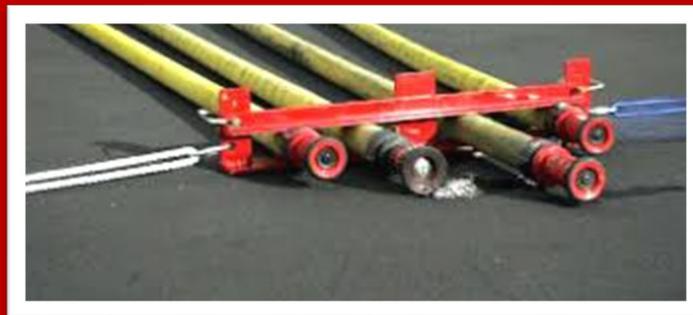
KEY REQUIREMENTS

1. Each hose shall be marked around its full circumference at the end or back of each coupling or collar to determine if the coupling or collar has slipped.
2. Personnel should stay clear of couplings during charging.
3. The pressure shall be raised slowly at a rate not greater than 15 psi per second.
4. Personnel shall never stand in front of the free end of the hose, on the right side of the hose, or closer than fifteen feet on the left side of the hose or straddle a hose in the test layout during the test.
