INCIDENT: SLIP/FALL ACCIDENT WHILE CLIMBING

SUMMARY OF RECENT INCIDENT

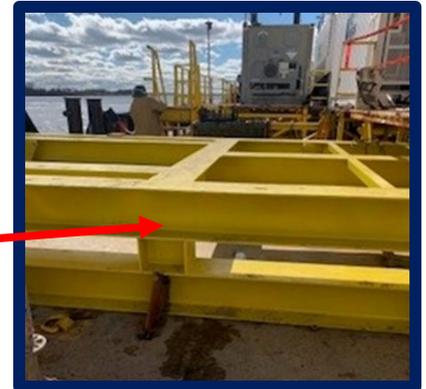
Work platforms are sometimes installed on the deck of the customer's vessels that personnel must cross in order to access work areas.

A recent incident occurred when a worker descended one of these platforms and tried stepping on the lower lip of the upper beam of the platform.

His foot slipped off causing him to fall approximately two feet onto the steel deck below.

Ship configuration may not allow for safe access and egress to all work areas.

Do not take shortcuts. Use safe routes where available.

Plan ahead as much as possible to assure workers can access all work areas safely. Consider opportunities to add scaffolding or other appropriate "engineered solutions" to allow safe passage for workers.

When workers encounter difficult or unsafe conditions they should report concerns immediately to the supervisor or HSE representative.
