INCIDENT: Ship Access

SUMMARY

Safe access to vessels is paramount for all members across the mutual to complete their work. Whether placed by the facility or the ship's crew, ensuring safe access is paramount to successful job completion.

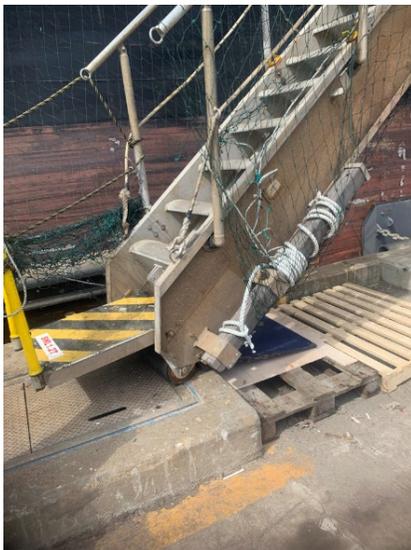
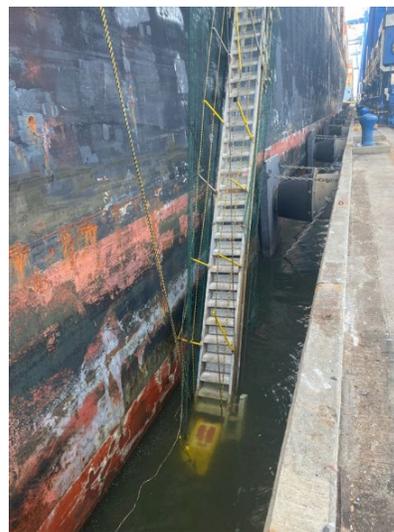
Example: The member alerted the vessel that the gangway was not safely footed on the pier. While re-positioning the hoist line parted, causing the gangway to fall into the water. Vigilant review before allowing employees access, prevented a potential injury event.

7. It is critical that the gangway/ramp safety be assessed and assured routinely over a shift. The gangway must be secured and appropriately trimmed. Ship lateral movement, tidal conditions, and other operational changes may result in the ramp access and safety being compromised. If the gangway/ramp shows gaps in access either at dockside or near the ship entrance, it must immediately be secured, and access denied until compliant with regulations. Adequate lighting should be provided to illuminate the means of embarkation and disembarkation, including the positions on deck and ashore.

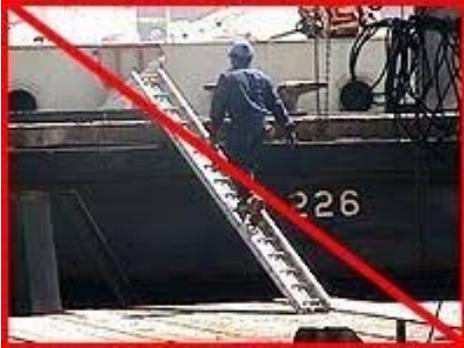
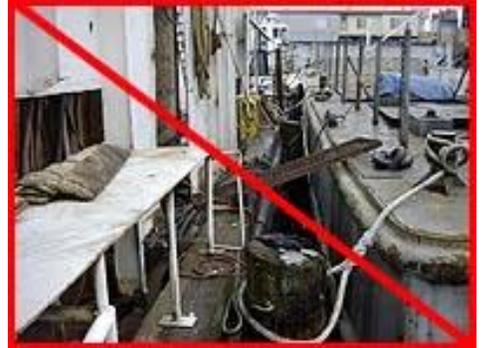
Improper Access- DO NOT USE

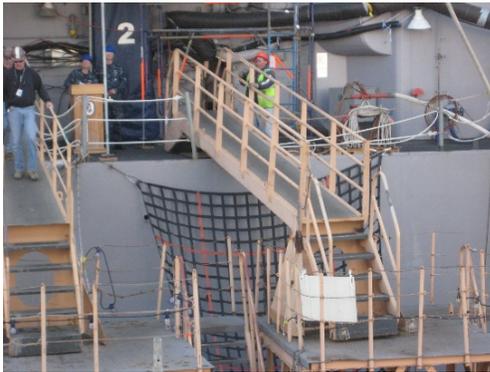
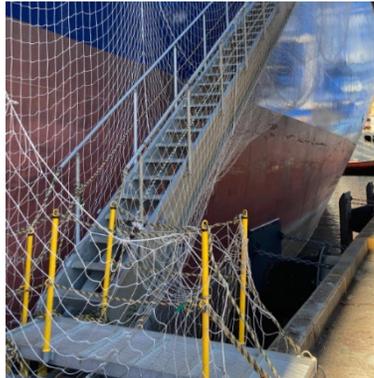
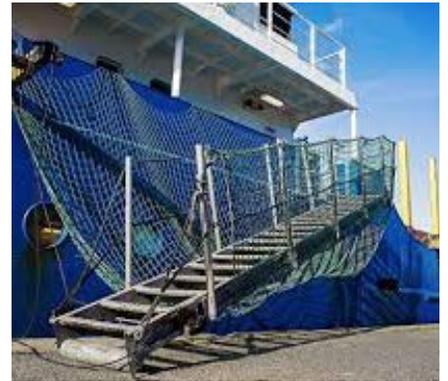
Properly Placed and Trimmed Gangways
